*Western  
Union*

# *Technical Review*

*October 1961*

PAGE
Plan 115 Switching System, H. JORGENSEN . . .	125
Application of "Gilmer-Type" Belts to Weatherfax Recorders, DOUGLAS M. ZABRISKIE . . .	133
Fishing versus Cables, C. S. LAWTON . . .	139
A Tape Rewinder for the Telecommunications Industry, WILLIAM V. JOHNSON . . .	145
Investigation of Electrical Contacts in Low Power Level Circuits, J. J. McMANUS . . .	149
The End of an Era, W. E. CRIPPEN . . .	158
Nell Organ Ramhorst . . .	161
Patents Recently Issued to Western Union . . .	162
Index . . .	164

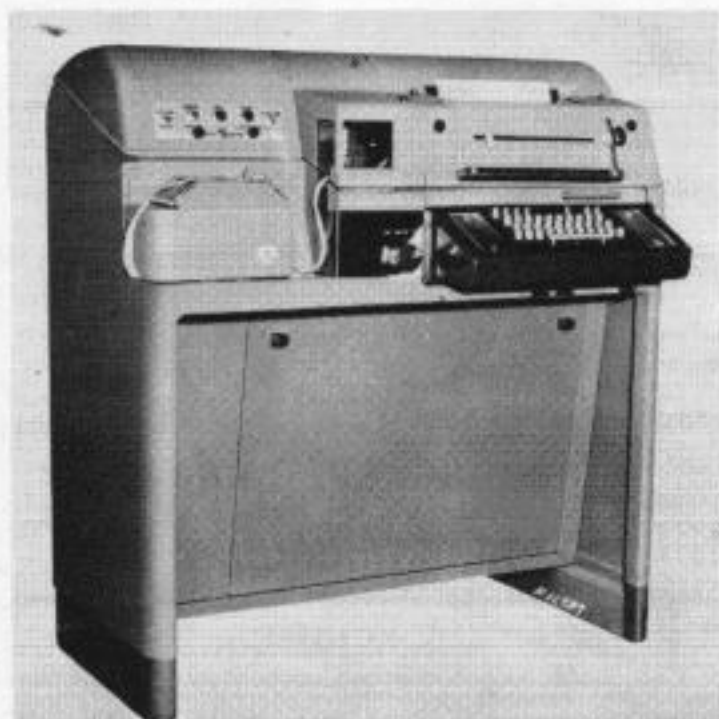
Photo R-11,939

Way Station Selector 10414-A
